Radon Inspection Report

Silverton Middle School
714 Schlador St.
Silverton , OREGON 97381

Type: Post-Mitigation

Inspection Report Date: 04/12/2019

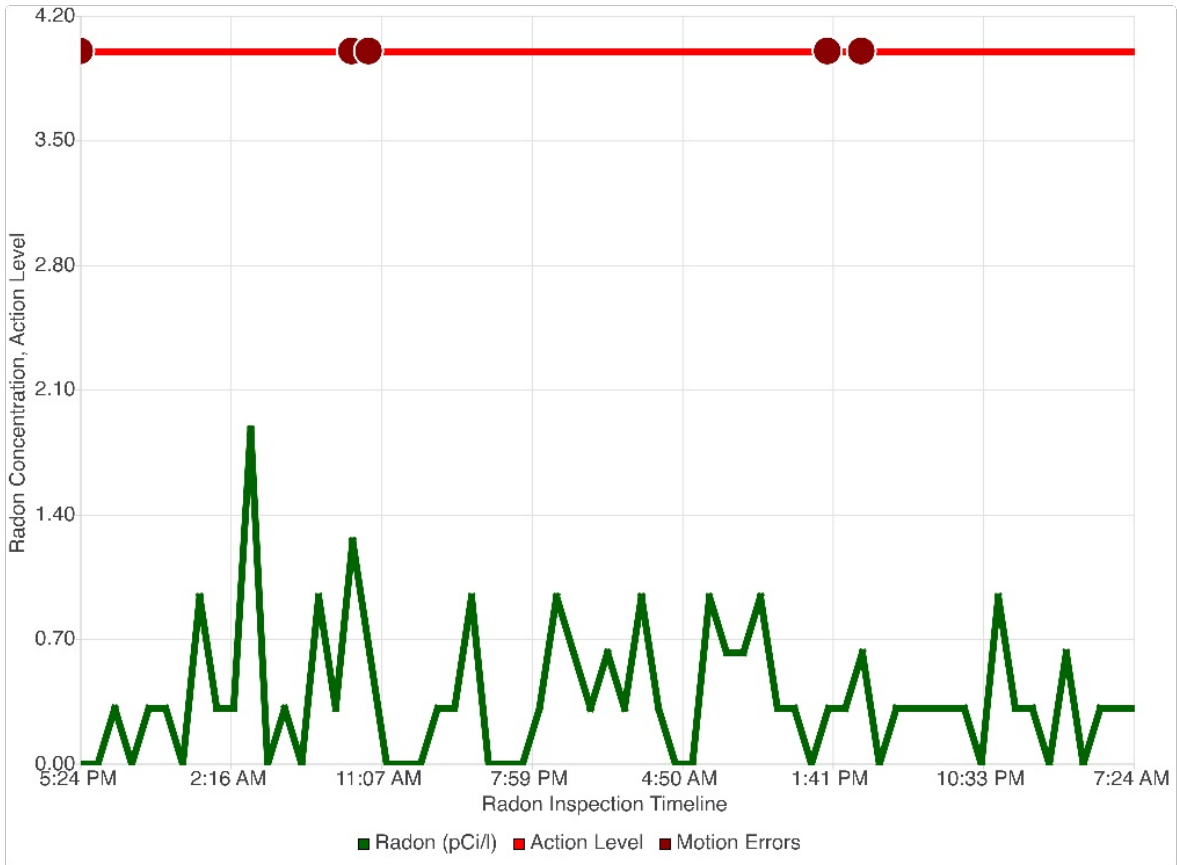
Radon Inspection Chart

Test Result: Pass

0.4 pCi/l

<u>CRM Location:</u> Girls PE Office	<u>Start:</u> 04/09/2019 04:24 PM	<u>Stop:</u> 04/12/2019 07:24 AM	<u>Interval:</u> 1 hr	<u>Duration:</u> 63 hr
Radon Concentration:	<u>Min:</u> 0.0	<u>Max:</u> 1.9	<u>Average:</u> 0.4	<u>Measurement Units:</u> pCi/l
