Radon Survey Analysis Job # 18-C108R

Silver Falls School District
Evergreen School
c/o Lorin Stanley

3727 Cascade Hwy.

February 13, 2019

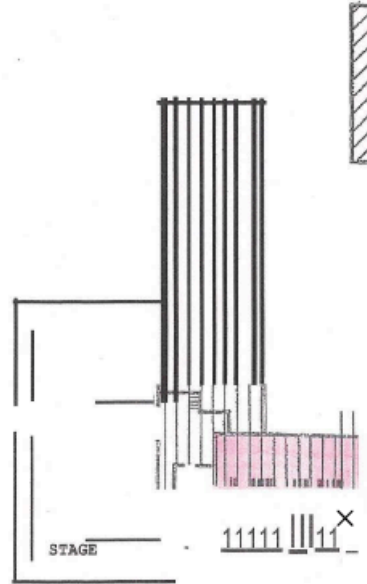
Test Location Map

Monitor ID 2045–Grade 6th, 7th, and 8th classroom

1Rm
Grade 6/7/8
with 1CRm

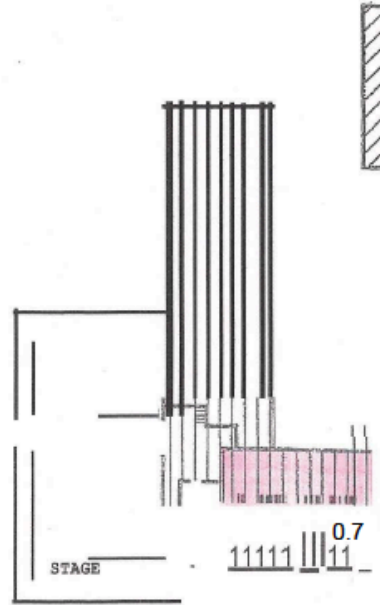
Test Results Map

Average radon reading for duration of test = 0.7 pCi/L

Highest level recorded: 2.0 pCi/L

Lowest level recorded: 0.0 pCi/L

1Rm
Grade 6/7/8
with 1CRm
