Radon Inspection Report

Silverton Middle School
714 Schlador St.
Silverton , OREGON 97381

Type: Post-Mitigation

Inspection Report Date: 04/12/2019

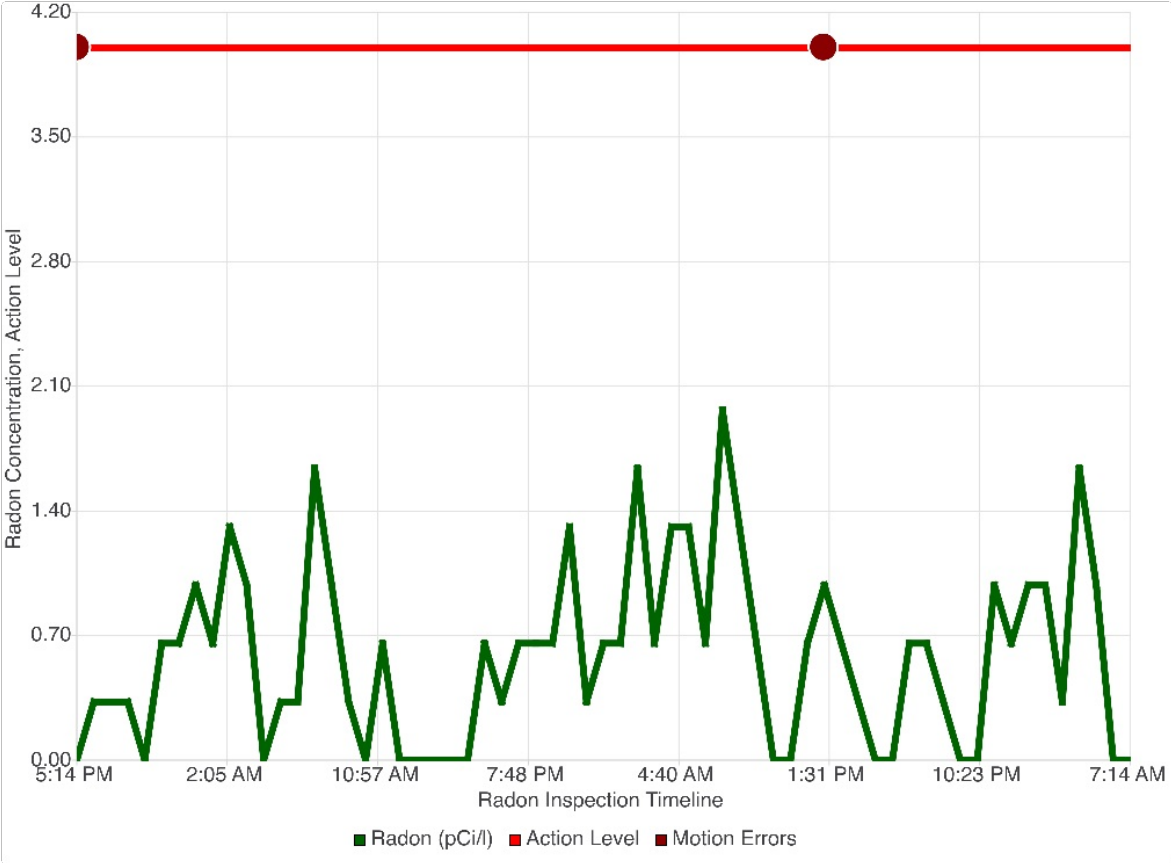
Radon Inspection Chart

0.6 pCi/l

<u>CRM Location:</u> Nurse Office	<u>Start:</u> 04/09/2019 04:14 PM	<u>Stop:</u> 04/12/2019 07:14 AM	<u>Interval:</u> 1 hr	<u>Duration:</u> 63 hr
Radon Concentration:	<u>Min:</u> 0.0	<u>Max:</u> 2.0	<u>Average:</u> 0.6	<u>Measurement Units:</u> pCi/l
