## Radon Inspection Report

Silverton Middle School  
714 Schlador St.  
Silverton, OREGON 97381

Type: Post-Mitigation

## Test Result: Pass

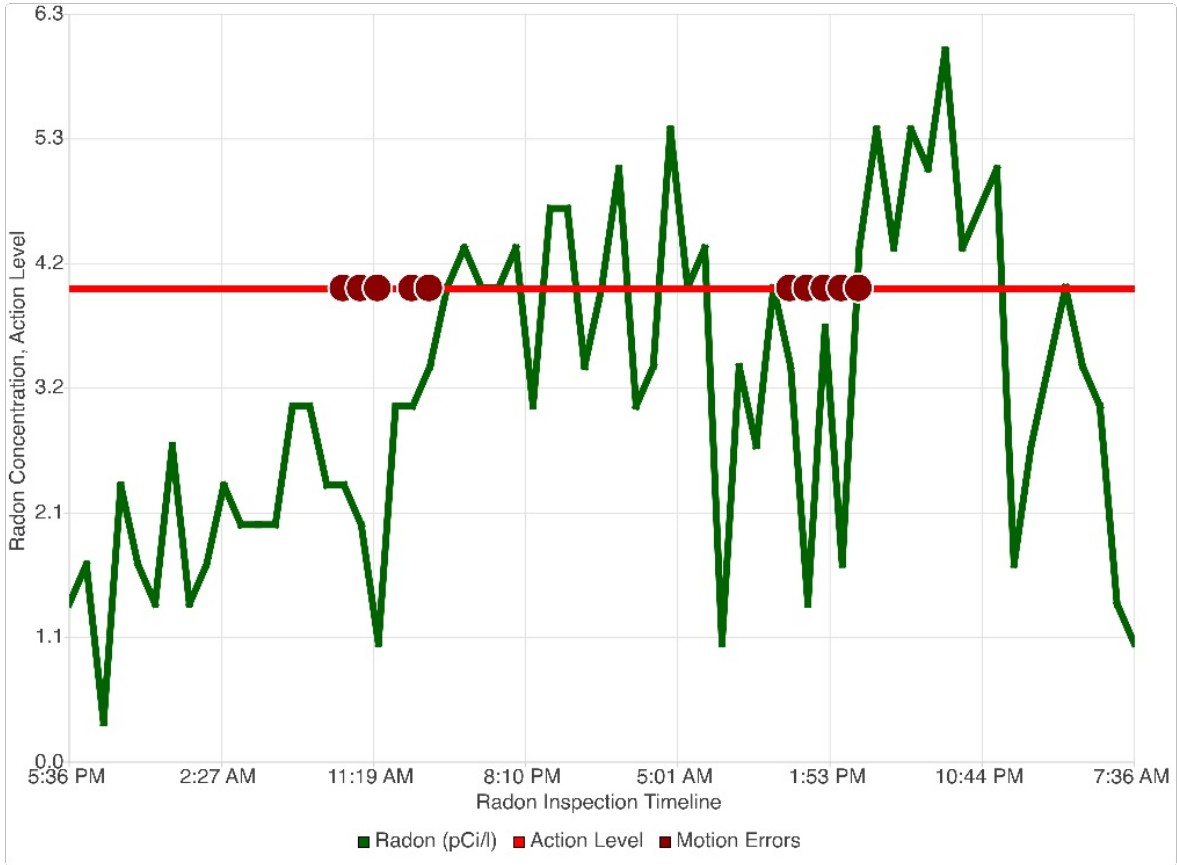
### Radon Inspection Chart

<u>CRM Location:</u> Boys locker room	<u>Start:</u> 04/09/2019 04:36 PM	<u>Stop:</u> 04/12/2019 07:36 AM	<u>Interval:</u> 1 hr	<u>Duration:</u> 63 hr
Radon Concentration:	<u>Min:</u> 0.3	<u>Max:</u> 6.0	<u>Average:</u> 3.1	<u>Measurement Units:</u> pCi/l
