# Radon Inspection Report

Silverton Middle School  
714 Schlador St.  
Silverton, OREGON 97381

Type: Post-Mitigation

## Test Result: Pass

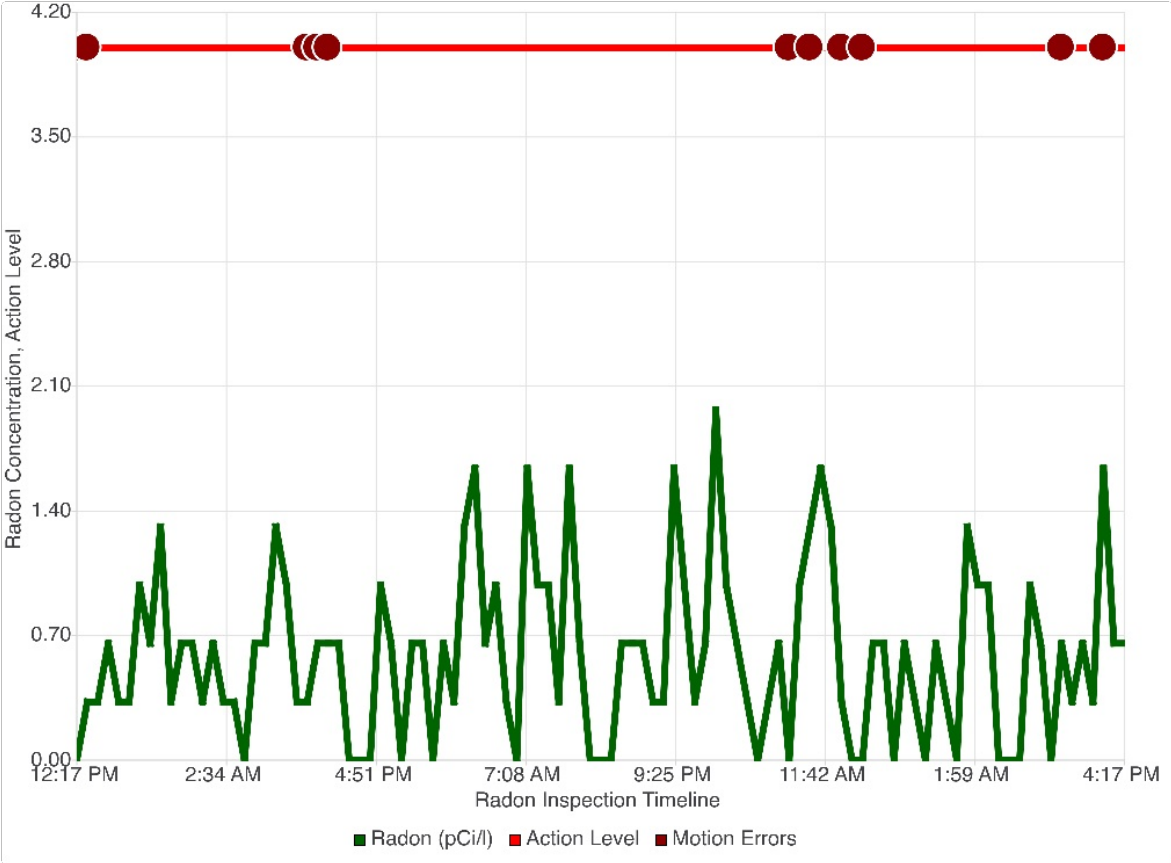
### Radon Inspection Chart

<u>CRM Location:</u> Girls Locker Room	<u>Start:</u> 04/15/2019 11:17 AM	<u>Stop:</u> 04/19/2019 04:17 PM	<u>Interval:</u> 1 hr	<u>Duration:</u> 101 hr
Radon Concentration:	<u>Min:</u> 0.0	<u>Max:</u> 2.0	<u>Average:</u> 0.6	<u>Measurement Units:</u> pCi/l
