# Radon Inspection Report

Silverton Middle School  
714 Schlador St.  
Silverton, OR 97381

Type: Post-Mitigation

Inspection Report Date: 11/25/2019

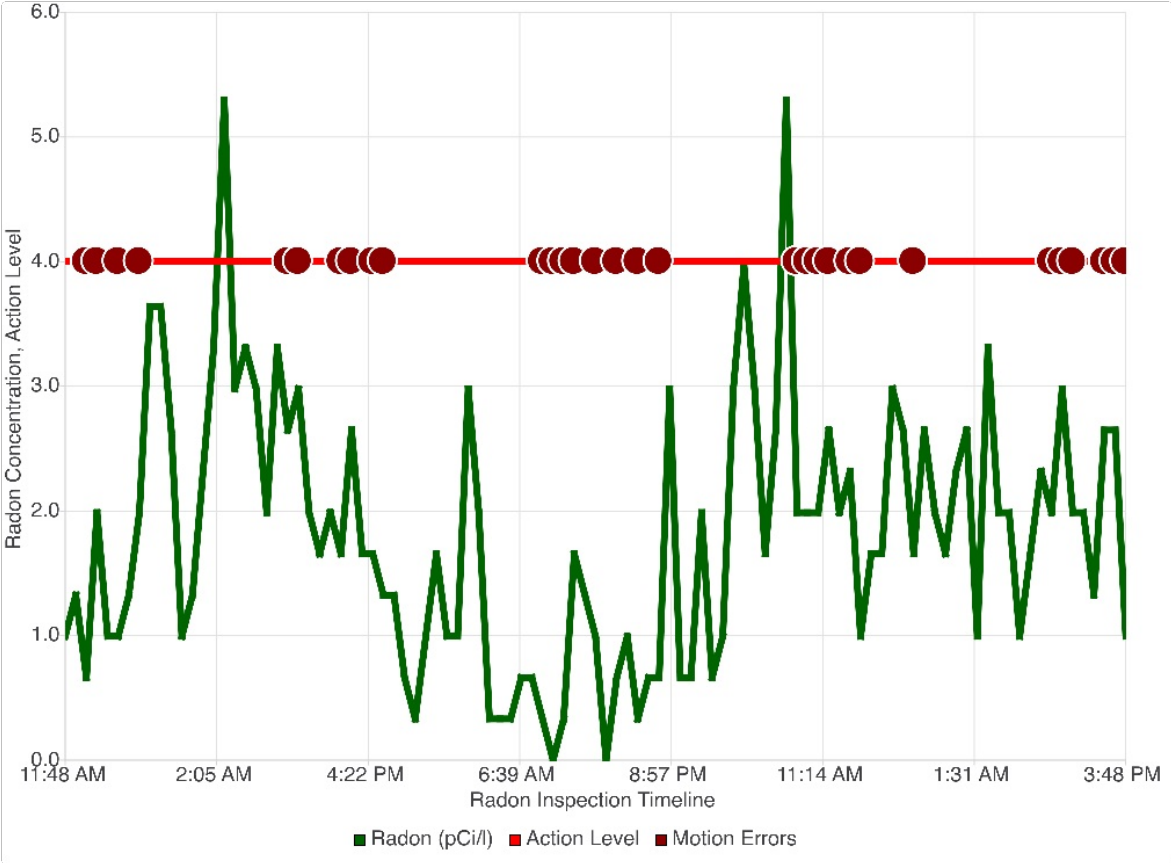
### Radon Inspection Chart

<u>CRM Location:</u>	<u>Start:</u>	<u>Stop:</u>	<u>Interval:</u>	<u>Duration:</u>
Boy's Locker room	11/18/2019 10:48 AM	11/22/2019 03:48 PM	1 hr	101 hr

<u>*First 4 hrs of data excluded</u>	<u>Min:</u>	<u>Max:</u>	<u>Average:</u>	<u>Measurement Units:</u>
Radon Concentration:	0.0	5.3	1.8	pCi/l

**Test Result: Pass**
